A CASE STUDY ON THE EVALUATION OF STRUCTURAL CONDITIONS FOR AN EXISTING BRIDGE USING POSITION SENSITIVE DETECTOR (PSD) DEVICE

Kenji Tada ^{*1}, Masayuki Hyodo, Dr. Eng., PE ², and Takaaki Miyasaka, PhD, PE ³, Jimmy Oshiro, PE, GE ⁴

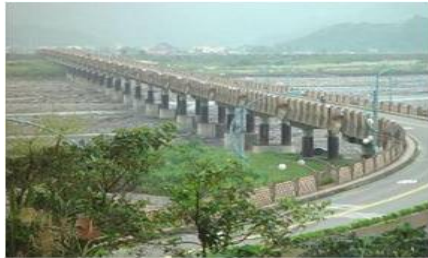
This case study was performed in Taiya Bridge's piers in Taiwan which is supported on caisson foundations (Figure 1). The river bed level was getting lower year by year resulting in the scouring of foundations. Thus, most of the caisson foundations were seriously exposed and there was a

Figure 1. Taiya Bridge View

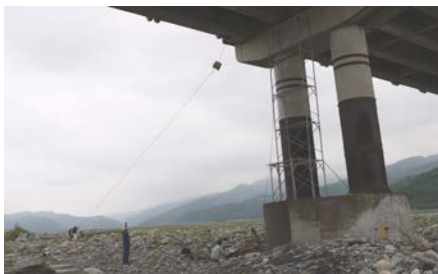
Figure 2. Impact Test

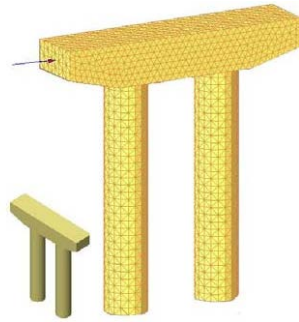
To simulate the pier's dynamic behaviours, Finite Element Method (FEM) Program Midas is employed to perform the nonlinear dynamic response analysis. The pier is modelled by 3 dimension solid element as shown in Figure 6. Material's nonlinear property is considered in the simulation analysis. Input external impact force is shown in Figure 7.

Figure 6. Simulation Model
